STUDY OF SIGN SYSTEM IMPROVEMENT IN A HISTORICAL PARK BASED ON BEFORE AND AFTER COMPARISONS

Hiroshi Tsukaguchi¹, Upali Vandebona², Hayato Mukai¹

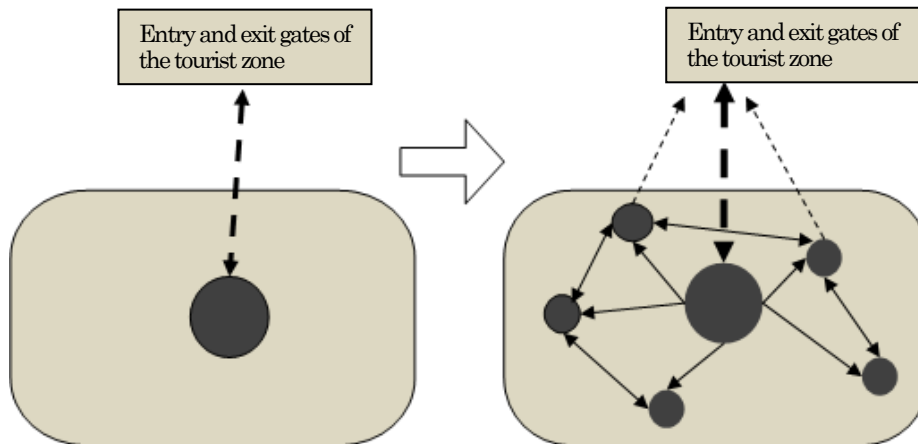
Figure 3 - Concept diagram of the design objective of the modified sign system

Right side of Figure 3 shows the concept related to signs catering to repeat visitors. This is achieved by providing a supplementary sign system in addition to the sign system that focuses on navigation among the main attractions. The challenge now is to build on basic familiarity possessed by repeat visitors and give them opportunities to explore beyond the main attractions to better appreciate what is left of a historical capital. As mentioned earlier, this requires wordy sign boards and diagrams because these signs are not only navigation aids but also has to function as rudimentary educational tools. In essence these signs are expected to encourage widespread circulation and provide a sense of confidence to visitors that they are unlikely to get lost. Objective of this form of signs is to allow repeat visitors to venture outside the dense activity zones and experience lesser ranked attractions as shown in Figure 3.

It is now possible to conceptualise a relationship between the needs of the two types of visitors and the rank of attractions. As mentioned earlier, newcomers are more interested in ‘must see’ attractions and cannot afford the time to immerse themselves in lesser known sites. Therefore, the focus of contents of the modified signs primarily targeting newcomers has been to navigate these visitors among rank A attractions. Left side of Figure 3 is a schematic representation of this design concept. These signs are devoted to navigation among the four major attractions already mentioned and attempts to minimise the information load on newcomers.

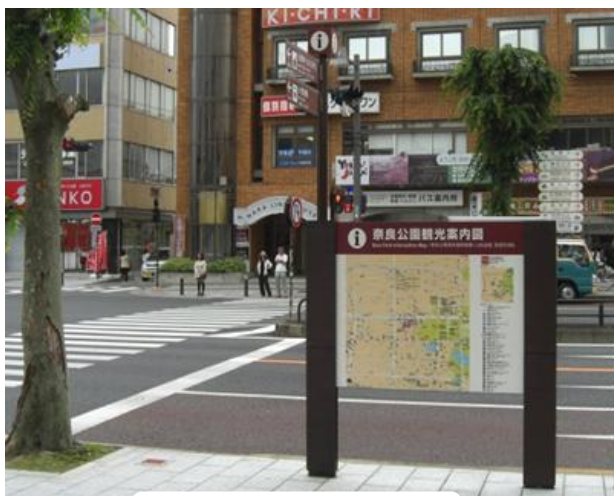
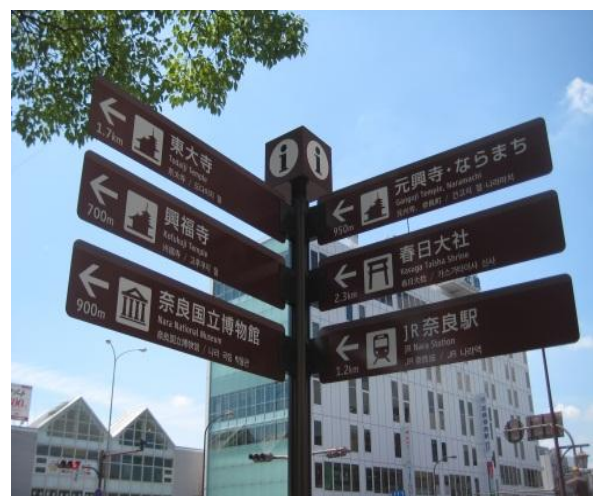
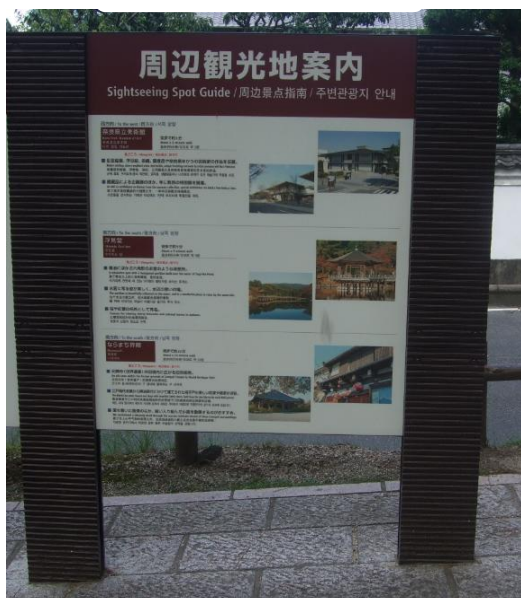
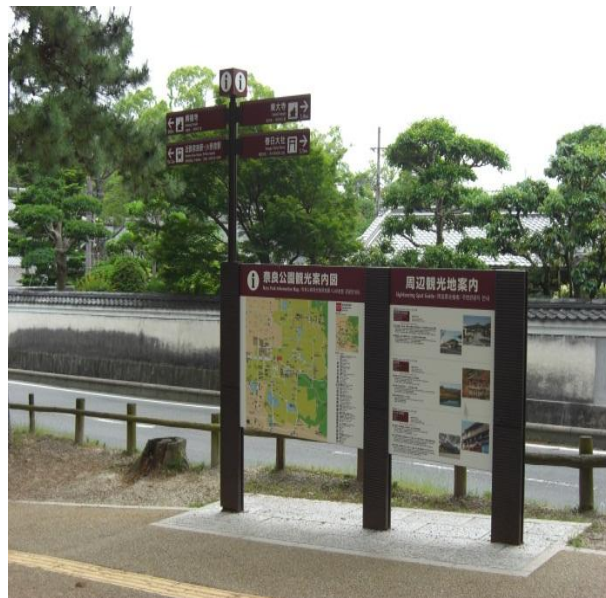
Figure 4- Examples of signs introduced during the modification

Map board by roadside

Arrow signs with distinctive icons

Explanatory board story book style

All three types could be combined as shown

There are three types of signs in the modified sign system of the Nara Park. They are named arrow signs, map boards and explanatory signs. The arrow signs are the simplest category. They are mounted on posts and the destination boards are precisely aligned and spaced to each other to avoid the old style haphazard appearance. To further reduce the clutter, the maximum number of arrow boards mounted on a post is limited to 6. And the maximum number of destinations that can be indicated by one arrow was set to 2. Symmetry of signs is attempted where possible for aesthetic reasons. A consistent symbol system similar to computer icons is also included in the destination board to indicate the type of destinations (see Figure 4). As these signs are the primary aid for newcomers, the arrow signs are mounted above the eye level of pedestrians. The top cap of these sign posts has been designed as a cube that displays the icon for information on its four sides to make the position of the post visible from a distant for anyone who may become anxious about directions.

Map boards and explanatory signs are vertical display panels, usually below the eye line of the visitors (see Figure 4). An appropriate title is at the top frame of these displays. These information panels are mounted on two side posts and the posts are driven into a paved surface to complete the professional appearance of these signs. These subsidiary signs play an important role in stimulating visitors and enhancing their experience of the day. Map boards are helpful in providing orientation as well as the overall layout of sites whereas explanatory signs are helpful in providing a narrative and photographs to explain significant details related to this heritage site. Figure 4 shows examples of the three types of signs implemented. One picture shows that there are situations when different types of signs are thoughtfully placed in the close proximity.
