# Metrobús Line 4, a Medium Level BRT concept for historic districts with advanced features

The final design and operations of Line 4 are respectful of these conditions. This paper summarizes the most important observations of an operational assessment of the corridor during the first months of operation, with a special focus on road safety issues. It also includes recommendations for improvement. This case study provides valuable information to practitioners seeking transit applications in historic districts, and a reference to researchers in urban public transport.

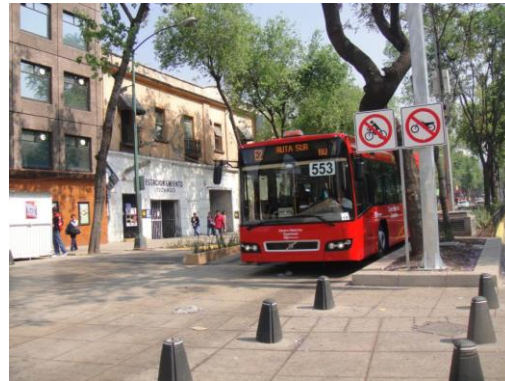
Figure 1b. Exclusive Bus Lanes and Urbanism

- Very narrow right of way (Figures 1b to 1e), with bus and pedestrian only streets in many sectors (Figures 1c and 1d)
- Recovery of public spaces previously encroached by streets vendors (Figures 1b to 1f)
- Low platform stations and terminals (Figures 1g and 1h)
- Smaller, low floor buses with more advanced propulsion technologies (Figures 1i and 1j)
- Curbside boarding and alighting (Figures 1d and 1i)
- On-board fare validation (single door entry, Figure 1i)
- Security cameras on board and user information screens (Figure 1i).
- Card sales and recharge only at terminals and external points, like mini markets.
- Totems to indicate bus stop location according to guidance by the downtown historic district authority (Figures 1d and 1f)
- Accessibility for people with different mobility needs (Figures 1d and 1i)

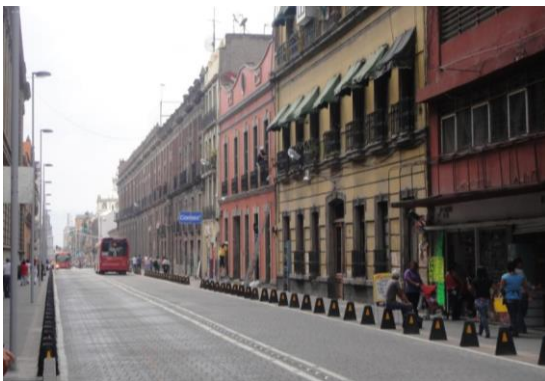
Figure 1c. Bus and Pedestrian Only Street

- Bus priority streets, semi-exclusive operation (Figure 1c). The lanes can be used for access to parking lots, but vehicles are not able to continue traveling for more than two blocks along the bus priority lane.
- Median exclusive lanes (Figure 1b).
- Curbside lanes shared with other public transport services (short sections where bus only lanes were not possible).

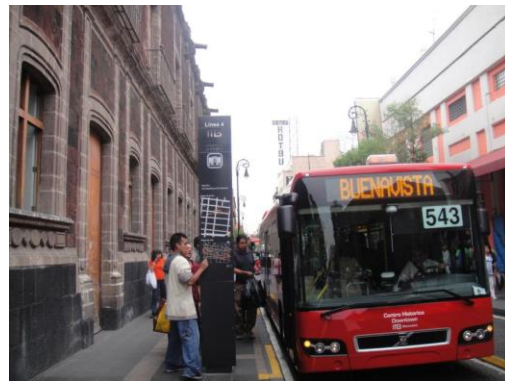
Figure 1d. Curbside Bus Station

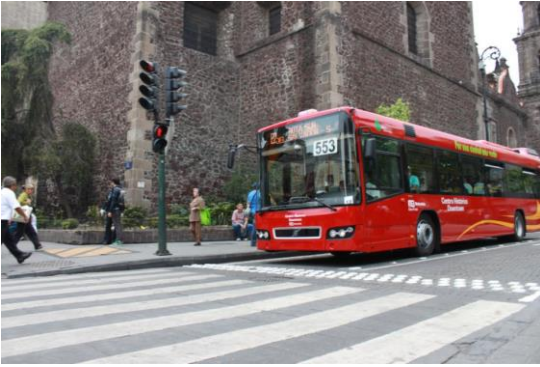
Figure 1e. Curbside Exclusive Bus Lane

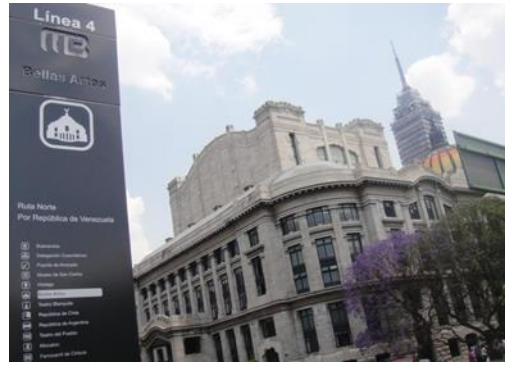
Figure 1f. Totem Marker at Bellas Artes Stop

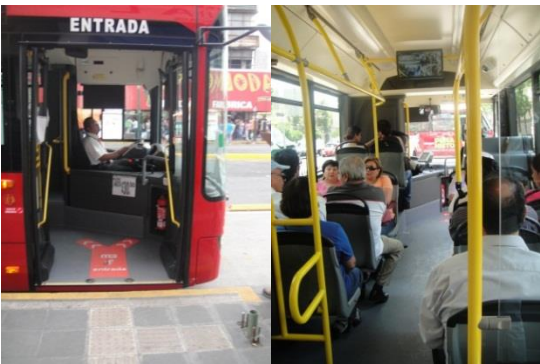
Figure 1i. Low Floor Entry and Bus Interior

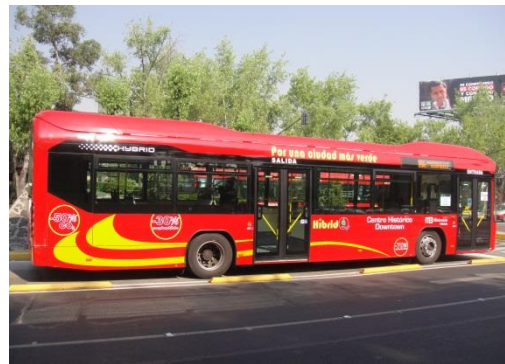
Figure 1j. Low Floor 12 Hybrid Bus

Line 4 includes a fleet of 54 EURO V low floor buses, with right hand side doors, 12 m length, and capacity for 90 passengers. Eight vehicles are hybrid Diesel-Electric buses; the first fleet of hybrid buses in México.

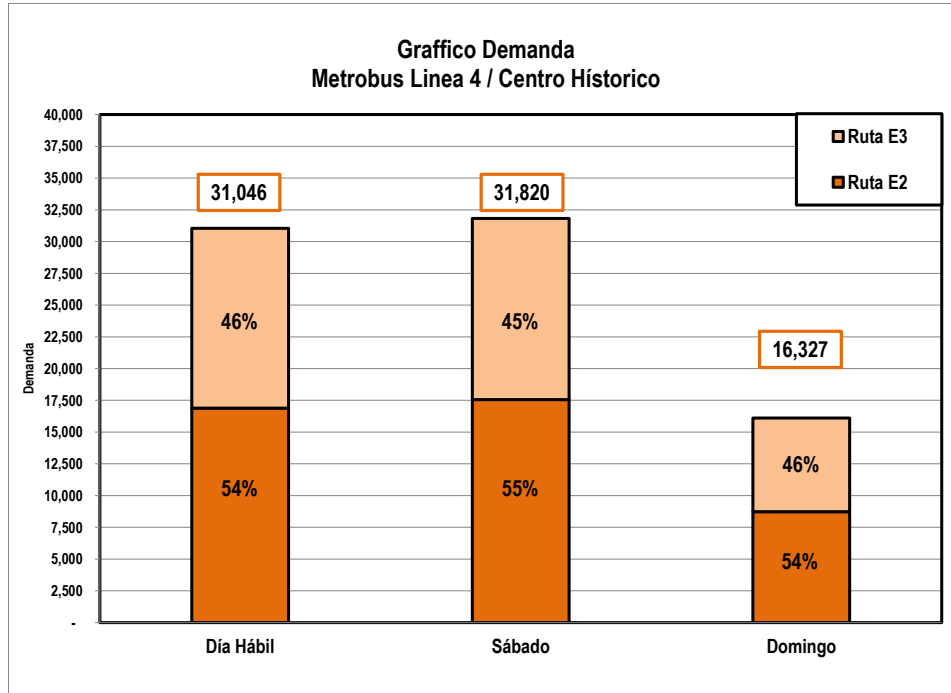
The line 4 carries 50,000 passengers per day (maximum reached 56,000 passengers per day in October 2012). Maximum ridership is observed on Saturdays, with a decrease in 3% during weekdays and 50% on Sundays (Priego et al, 2012, Figure 2). The route “E2” is the most demanded

Figure 2. Passenger Ridership by Day of the Week (May 2012)

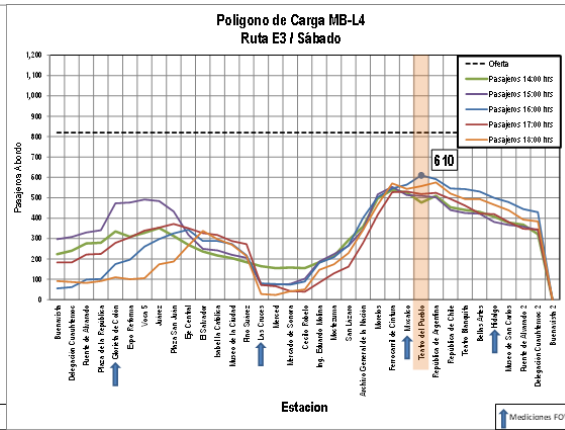
concentrating 55 percent of the total ridership. Passenger maximum load was observed at 668 passengers per hour per direction (Priego et al, 2012, Figures 3a and 3b).

Figure 3b Boardings Route E3-Saturday

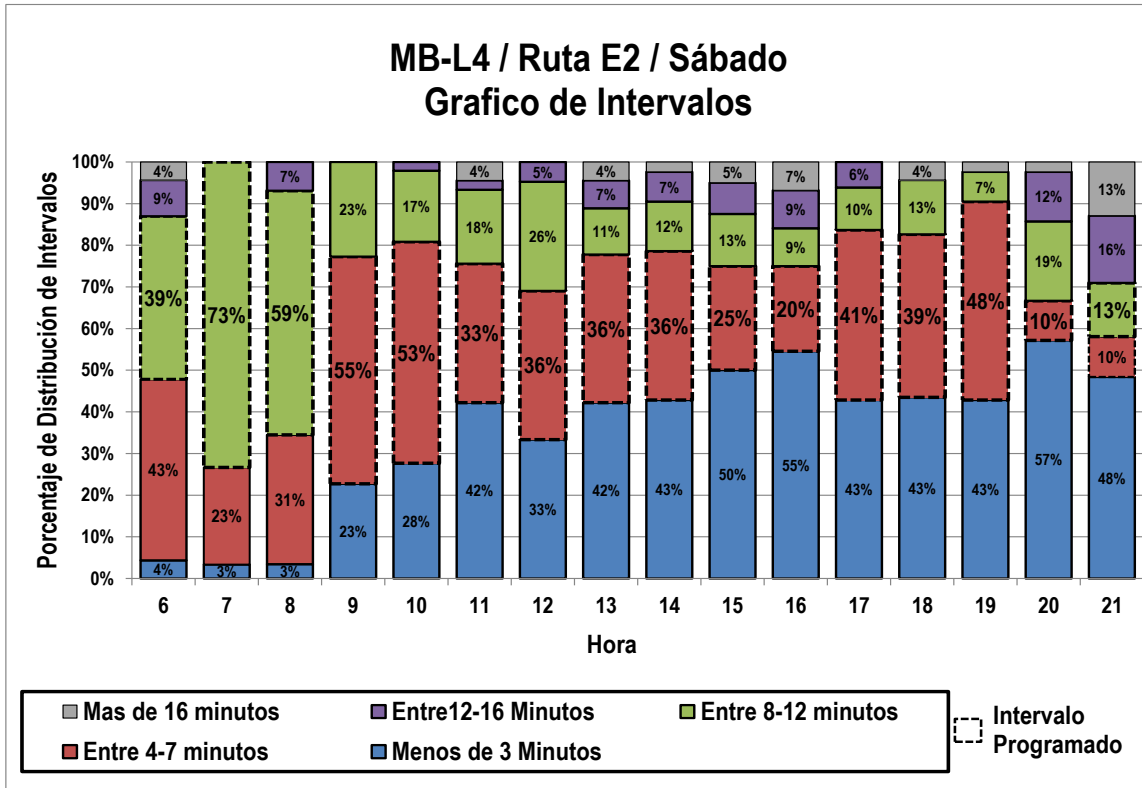
Field observations indicate lack of regular service frequency. Less than 50 percent of the arrivals occurred within the programmed headway. Irregular service causes long waiting times for a large proportion of users. The longest measured waiting time was of 24 minutes, for a programmed 3 minute interval.

Figure Intervals route E2-Saturday

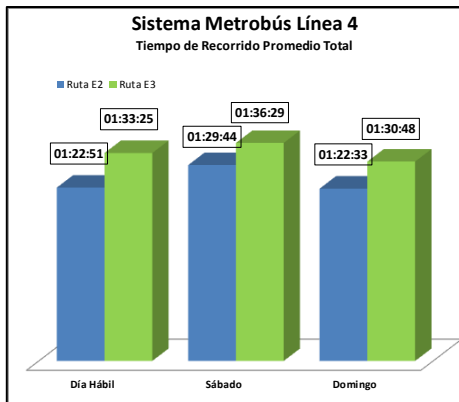
Peak cycle time is between 1:22 and 1:36 hours depending on the loop and the day of the week. The south loop E3 takes less time than the northern loop E2 (Figure 5a). Travel speeds are 9.9 km and 9.0 km/hr respectively (Figure 5b). There are large speed variations along the routes, with a minimum of 4.1 km/h and a maximum of 19.1 km/h (Figure 5b).

Figure 5a. Cycle Times

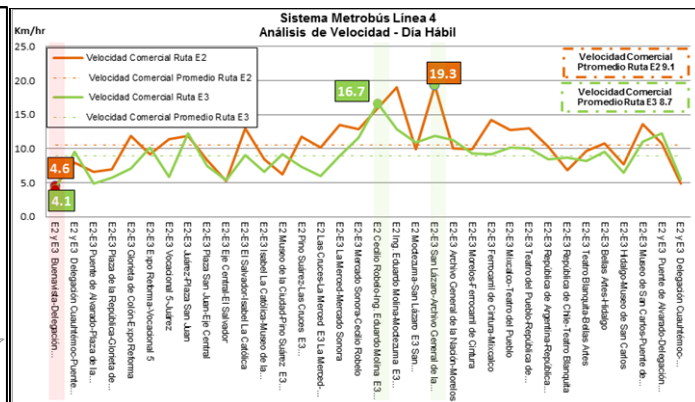
Figure 5b. Travel Speeds

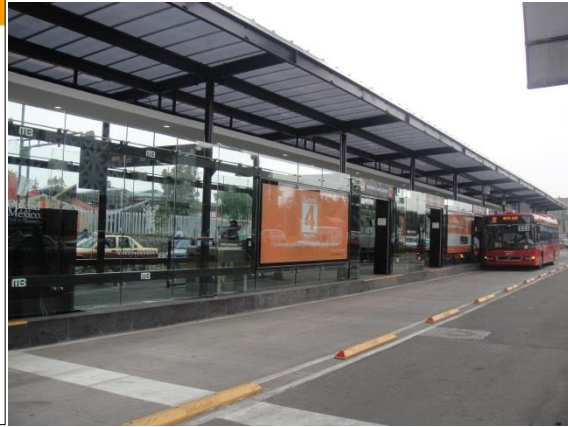
Figure 7b. Terminal Station San Lázaro

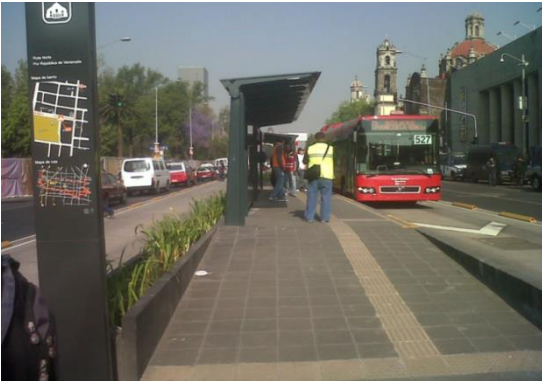
Figure 7c. Ramp, Platform and Bus Shelter

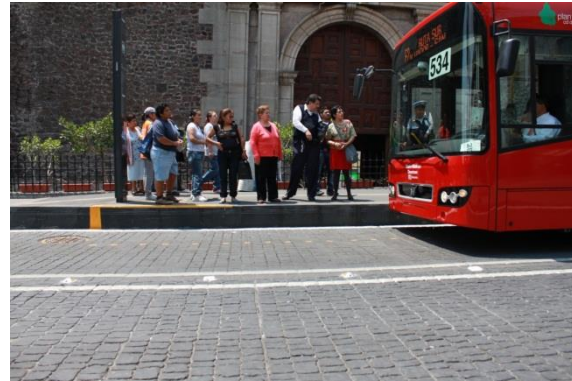
Figure 7d. Platform with Totem

- The manual docking on the far side of the driver is difficult; some buses have scratches in the right hand side.
- The totems are good solution for the architectonic restrictions set forth in the Historic Center. Nevertheless these stops do not provide any protection for sunlight and rain to the passengers.

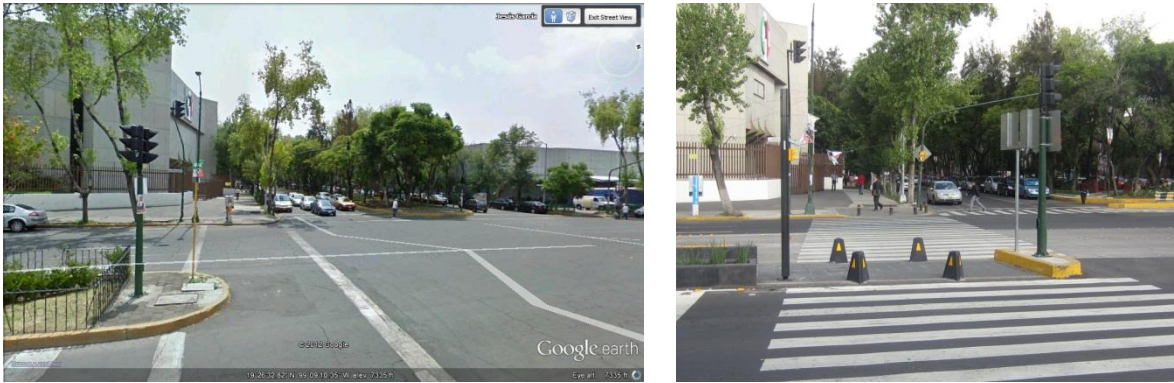
The number of intersections along the corridor featuring protected pedestrian space increased from 21 (27%) before the audit to 73 (93%) after the implementation of audit recommendations. Figure 10 shows the condition before and after at a particular intersection (*Jesus Garcia and Luis Donaldo Colosio*).

**Figure 10. Pedestrian Crossing at *Jesus Garcia* and *Luis Donaldo Colosio* Before (2011) and After (2012)**

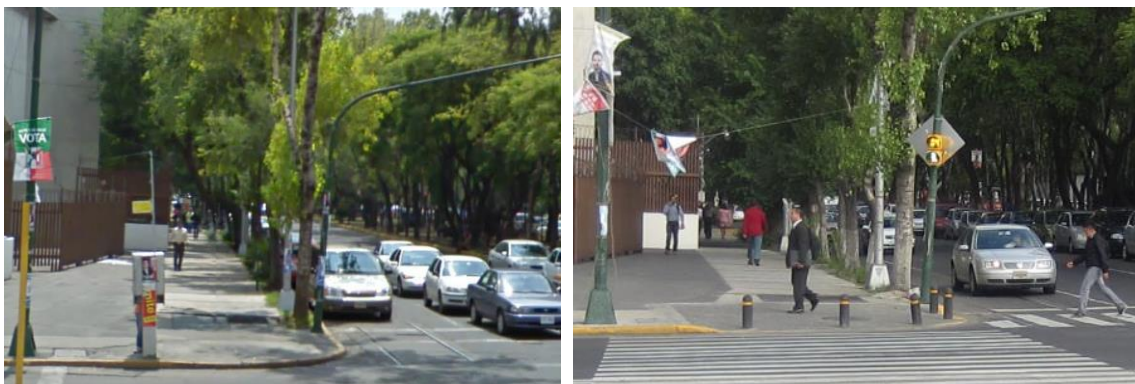
The number of signalized intersections along the corridor featuring pedestrian signals increased from 37 before the audit to 49 after the implementation of audit recommendations (a 32% increase). Figure 11 shows the traffic signals in a particular intersection before and after the implementation of the corridor.

**Figure 11. Pedestrian Crossing at *Jesus Garcia* and *Luis Donaldo Colosio* Before -without Pedestrian Traffic Signal (2011) and After- With Pedestrian Traffic Signal (2012)**

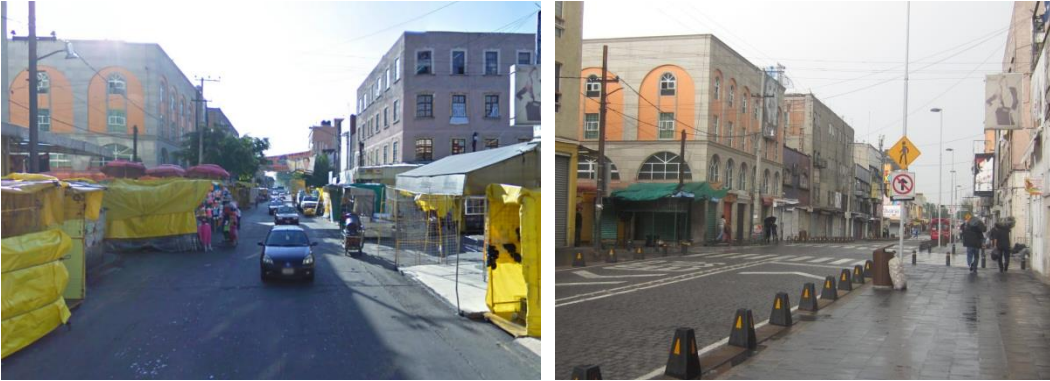
Extensive pedestrian areas were recovered, previously encroached by street vendors, particularly in the area of *La Merced* market. Figure 12 indicates the conditions before and after the intervention in *Miguel Alemán* Street.

Figure 12. Sidewalks in *Miguel Alemán* Street before (2011) and after the corridor implementation (2012).

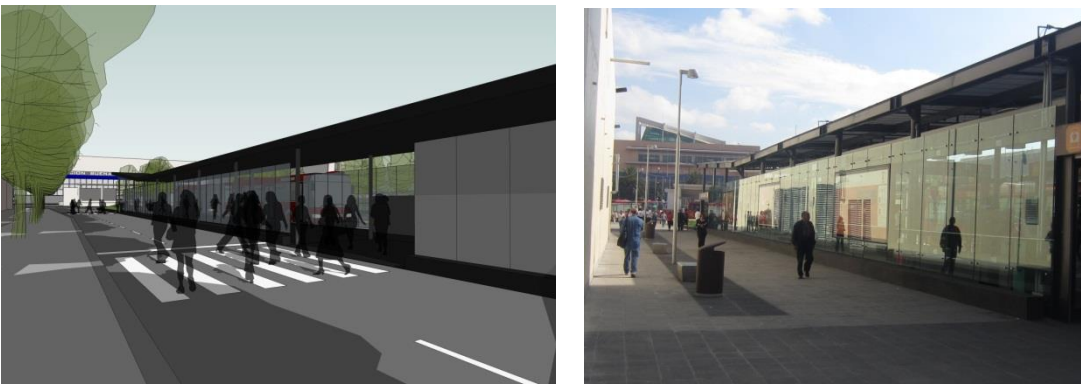
The original design of the terminal at *Buenavista* (*Puente de Alvarado* Street) involved the potential of several conflicts between pedestrians and general traffic. The audit recommended pedestrianizing the street to provide safe access. This recommendation was implemented (Figure 13).

Figure 13. Render of the design of pedestrian access to *Buenavista* Terminal before the Road Safety Audit (2011), and Actual Pedestrian Street to Access the Terminal (2012)

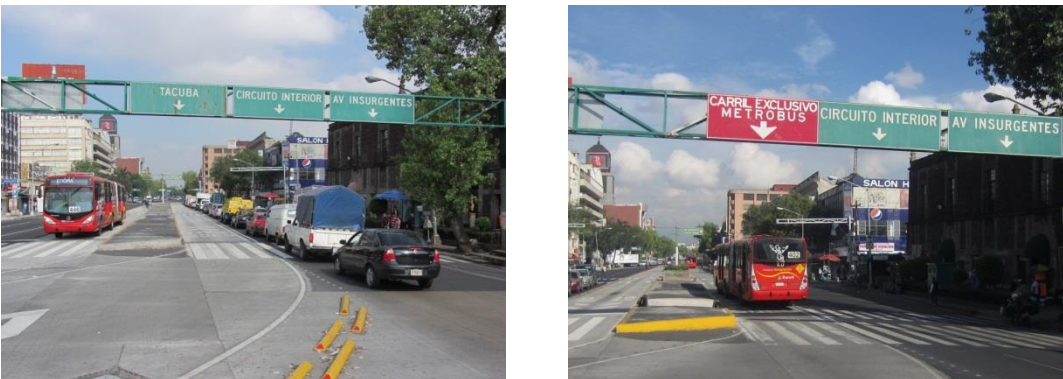
Overhead signs did not provide clear indication of the exclusive bus lanes. The road safety audit recommended special colored signs to increase visibility to general traffic. Figure 14 shows how the overhead signs were modified.

Figure 14. Overhead signs before and after interventions at *Puente de Alvarado* Street.

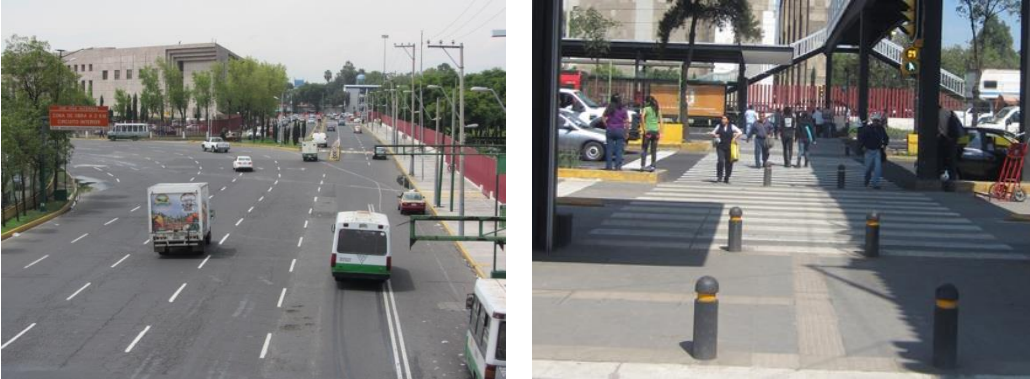
Special traffic calming features were recommended in the road safety audit and implemented in the project. Figure 15 shows *Eje 3 Eduardo Molina*, which is a very wide street with high vehicle speeds and frequent jaywalking. It was considered a mayor black spot for run-overs. The implemented project includes a signalized pedestrian crossing, with very clear zebra crossing paint, and four refuge islands to break up the crossing and provide additional safety to pedestrians.

**Figure 15. Eduardo de Molina Av. Before (2011) and After (2012) the intervention, displaying good protection for pedestrians.**
