ERGONOMIC INTERVENTION AT LOADS STORAGE AND TRANSFER ON VESSELS OF AMAZON STATE

Keywords: Vessels, loads storage and transfer, ergonomics.

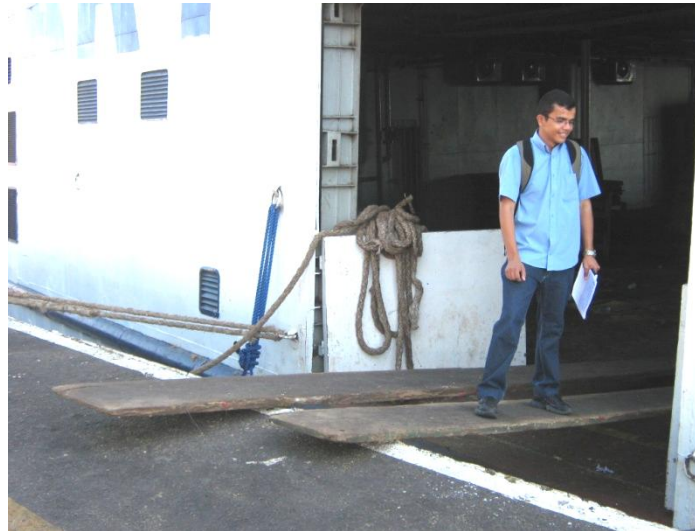
Figure 3 - Accidents problems.

At figure 3, it can be seen two improvised ramps, without fixation and handrails, used to access a vessel. The instability of the boat can cause accidents.

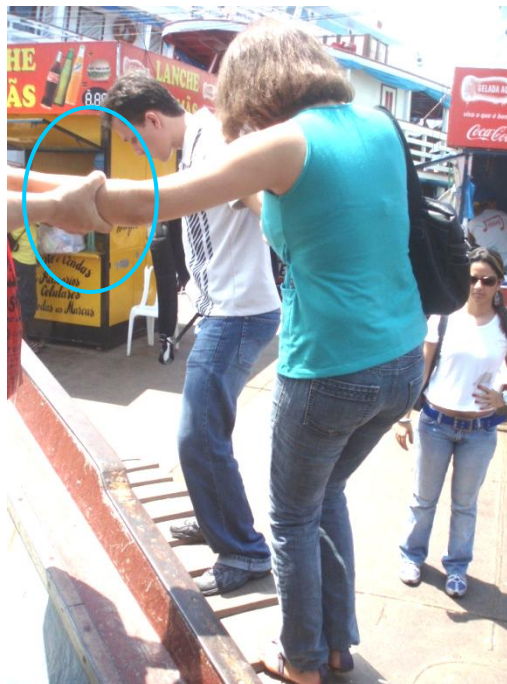
Figure 4 - Accidents problems.

At figure 4, it perceives that two people need help from others to get off the boat because the access ramp is narrow and has no handrail.

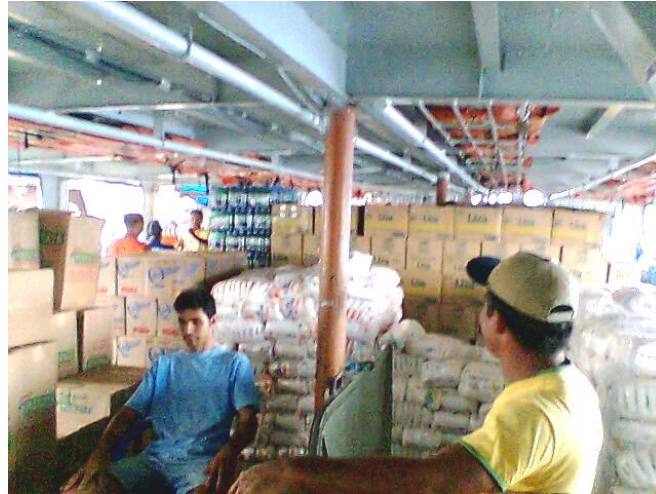
Figure 5 - Problems of accidents and displacement.

At figure 5, it can be noted a vessel where goods occupy almost the entire space of the deck, obstructing the free movement of persons. The absence of fixation on the loads is also observed and may cause accidents.

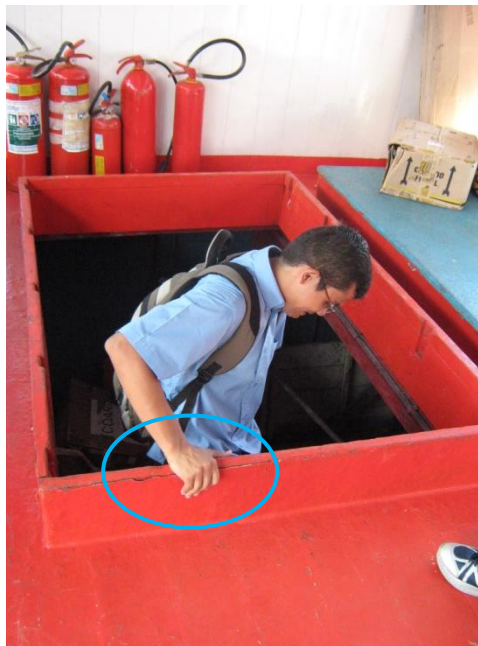
Figure 6 - Accidents problems.

It is observed, at figure 6, that the stair to the hold has no handrail. The user needs to improvise to get there in safe.

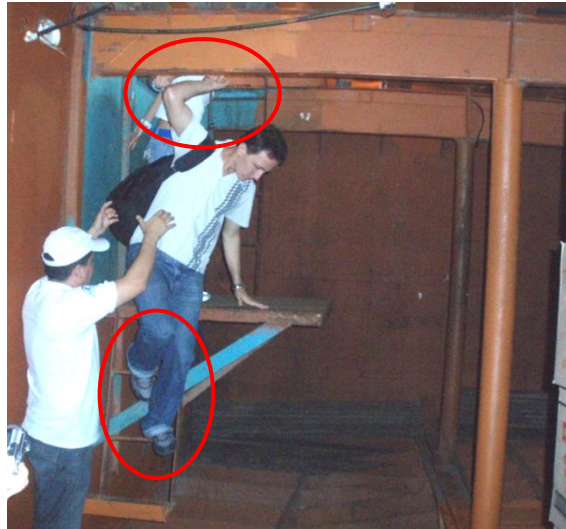
Figure 7 - Problems of accidents.

It can be noted, at figure 7, that the access to the hold of the vessel is hampered by the fact that the ladder is made of metal tubing (material and shape that make hard to grip) and has no handrail. The small distance between the baseline and the hatchway turns the access harder. That situation causes discomfort to users and can generate accidents.

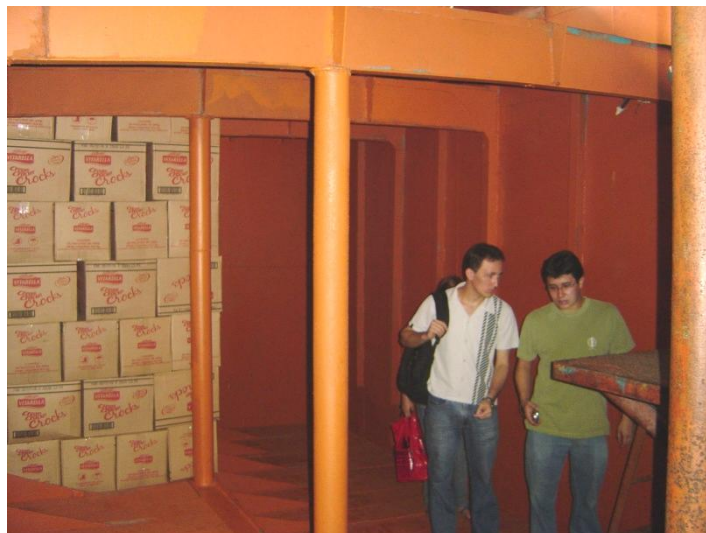
Figure 8 - Problems of accidents.

In figure 8, it can be observed that the goods stored in the bilge have no protection. This condition may cause accidents with loss of product.

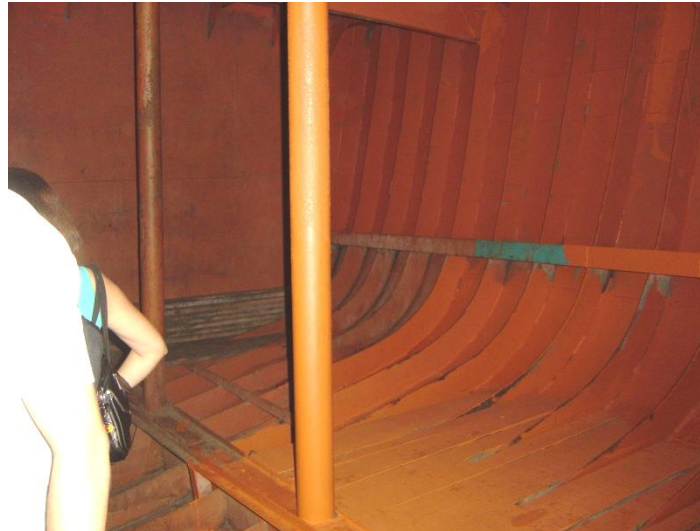
Figure 9 - Problems of space / interiors architecture.

In figure 9, it is perceived that the surface of the hold follows the format of the ship's hull. The absence of coating on the floor creates an irregular and insecure workplace, not offering equilibration to the loads.

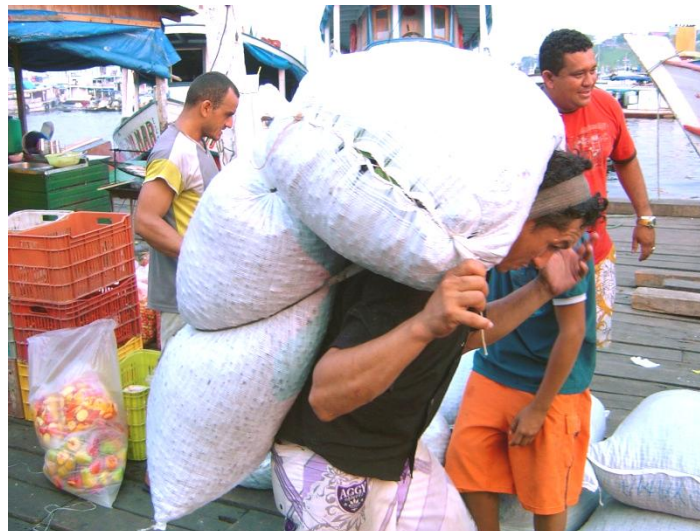
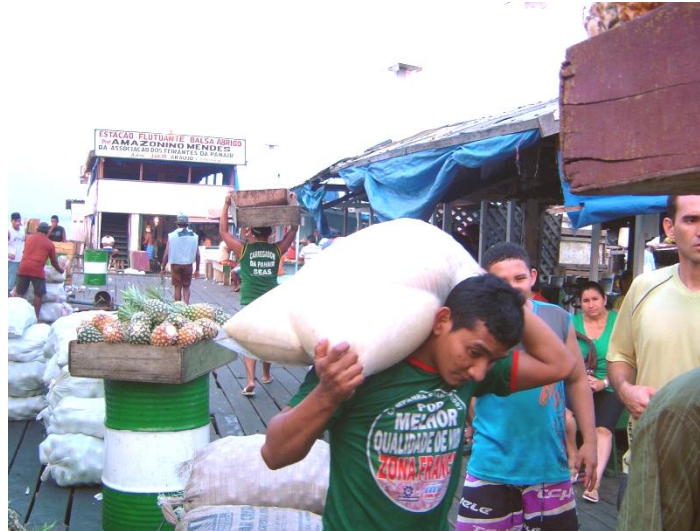
At figures 10 and 11, it is noted that, because of the absence of equipments for cargoes transportation, the stevedores realize the loading manually, usually, carrying excess of weight on the head and spine, what can cause serious damage to muscular and skeletal systems.

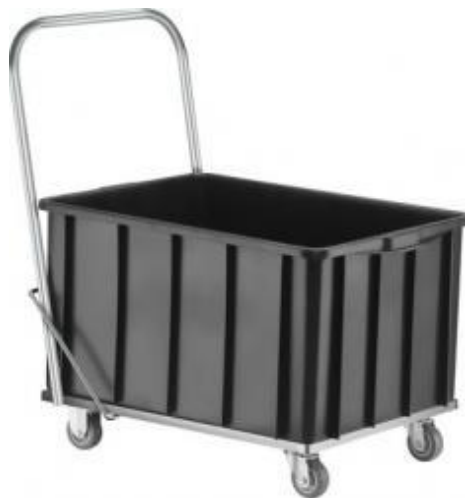
Figure 14 - Cart for boxes.

At figure 14, there is a car for cargoes transportation, made of steel, with internal dimensions of 390 x 510 x 690 mm and external of 410 x 560 x 780 mm (height x width x depth), and capacity for 130 l.

Positive points: it transports large capacity of loads and is made of resistant material.

Negative points: it is small.
